# Technical Appendix 9.1: Watercourse Crossing Report

# **Revised Larbrax Wind Farm EIA Report**

## **Appendix 9.1: Watercourse Crossing Report**

**December 2024**

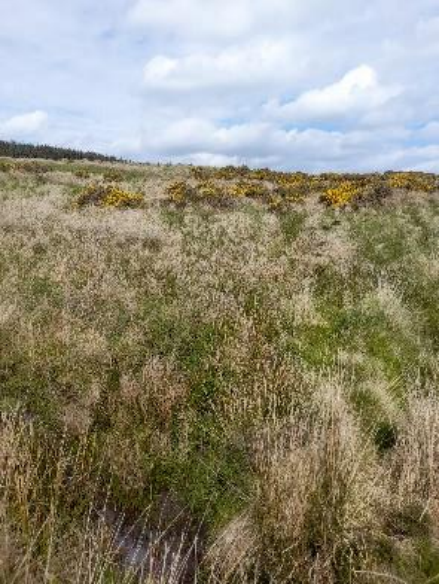
ID	Name	Easting	Northing	Field Notes / Comments	Width (m)	Bed Sediment	Bank Erosion (yes/no)	Natural Channel (yes/no)	Crossing Type	Existing Culvert/ Bridge Dimensions	Catchment (km²)	Minor Watercourse (yes/no) <sup>2</sup>	CAR Authorisation Required (yes/no)	Photograph
NC1	Unnamed watercourse	196485	562207	No channel but likely a flow pathway; boggy despite dry day	-	-	-	-	New crossing, Bottomless culvert	N/A	0.007	Yes	No

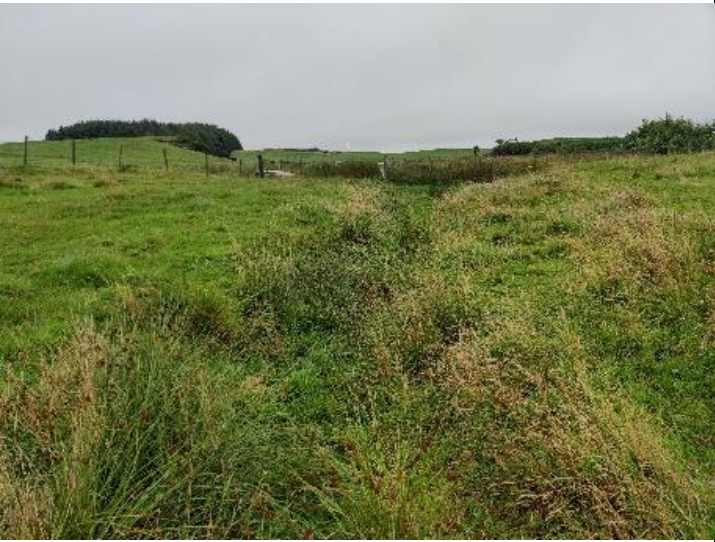
NC2	Unnamed drain	196785	562180	Outflow from pond. No water	1	Soil	N	N	New crossing, Bottomless culvert	N/A	0.037	Yes	No

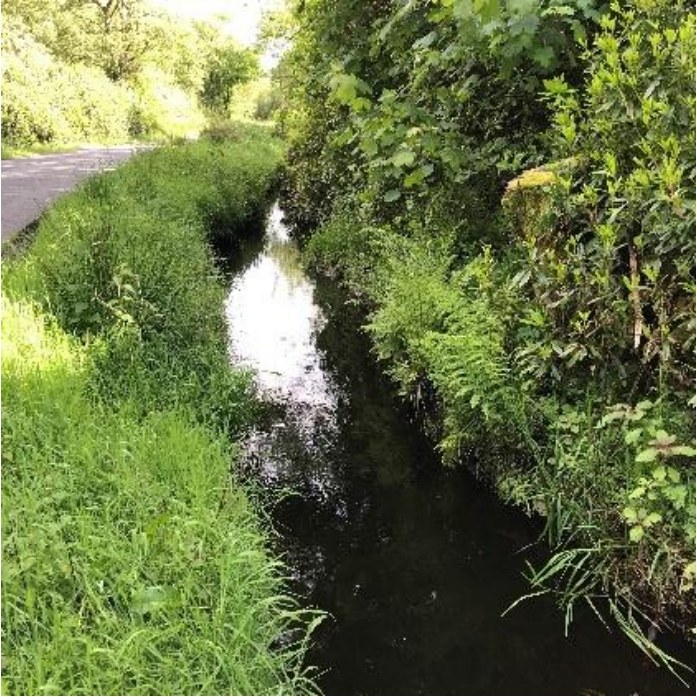
ID	Name	Easting	Northing	Field Notes / Comments	Width (m)	Bed Sediment	Bank Erosion (yes/no)	Natural Channel (yes/no)	Crossing Type	Existing Culvert/ Bridge Dimensions	Catchment (km <sup>2</sup> )	Minor Watercourse (yes/no) <sup>2</sup>	CAR Authorisation Required (yes/no)	Photograph
NC3	Unnamed drain	196899	562097	Channel not well defined; no water present	0.4	None – grass in drain	N	N	New crossing, Bottomless Culvert	N/A	0.002	Yes	No	 
NC4	Green Burn	197959	561926	Flows alongside main road, variable widths and bank heights	2.2	Cobble and Gravel	Y	Y	New crossing; Bottomless Culvert (see Appendix 9.4 and Figure 4.11b)	N/A	2.99	No	Yes (Simple License)

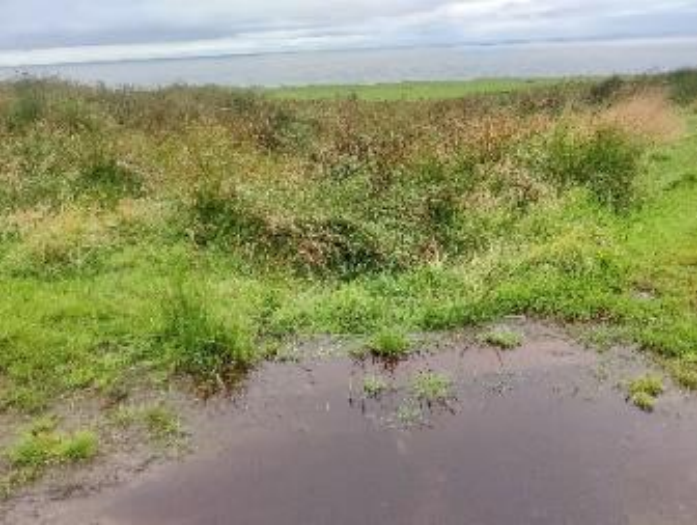
ID	Name	Easting	Northing	Field Notes / Comments	Width (m)	Bed Sediment	Bank Erosion (yes/no)	Natural Channel (yes/no)	Crossing Type	Existing Culvert/ Bridge Dimensions	Catchment (km²)	Minor Watercourse (yes/no)²	CAR Authorisation Required (yes/no)	Photograph
UC1	Unnamed watercourse	196450	562297	Probably ephemeral	0.75	Gravel	Y, from cattle	N	Upgrade to existing track, Bottomless Culvert	N, ford	0.018	Yes	No

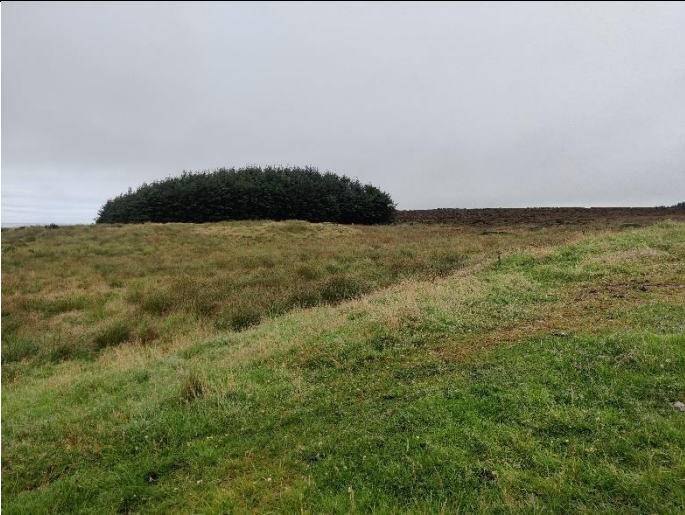
UC2	Unnamed watercourse	196609	562252	Blocked culvert so effectively a ford	0.6	Gravel	Y	N	Upgrade to existing track, Bottomless Culvert	-	0.029	Yes	No

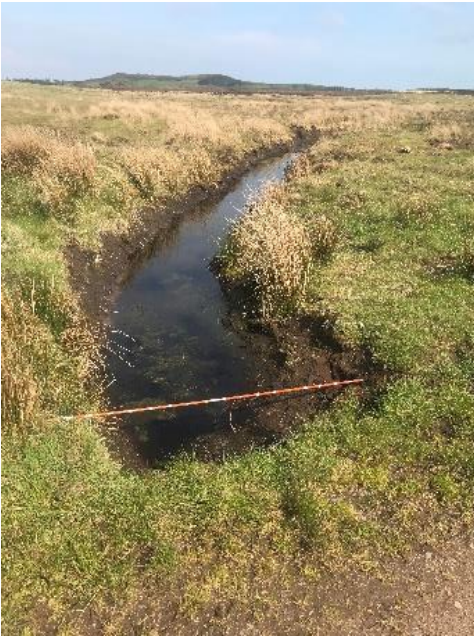
ID	Name	Easting	Northing	Field Notes / Comments	Width (m)	Bed Sediment	Bank Erosion (yes/no)	Natural Channel (yes/no)	Crossing Type	Existing Culvert/ Bridge Dimensions	Catchment (km²)	Minor Watercourse (yes/no)²	CAR Authorisation Required (yes/no)	Photograph
UC3	Unnamed drain	197074	561846	Flows though culvert and continues underground	1.5	Clay/silt	Y	N	Upgrade to existing track, Bottomless Culvert	200mm diameter	0.019	Yes	No

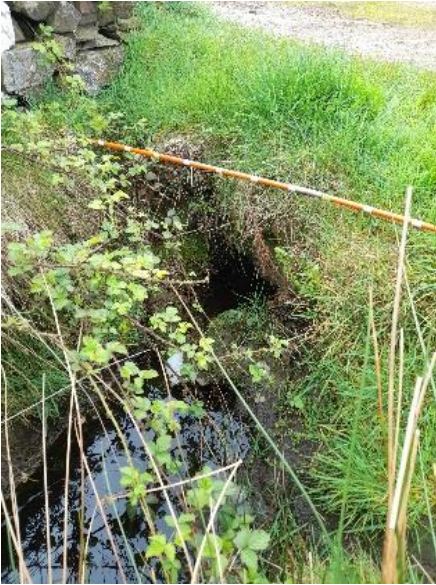
UC4	Unnamed drain	197140	561716	-	0.6	Clay/silt	N	N	Upgrade to existing track, Bottomless Culvert	320mm diameter	0.027	Yes	No

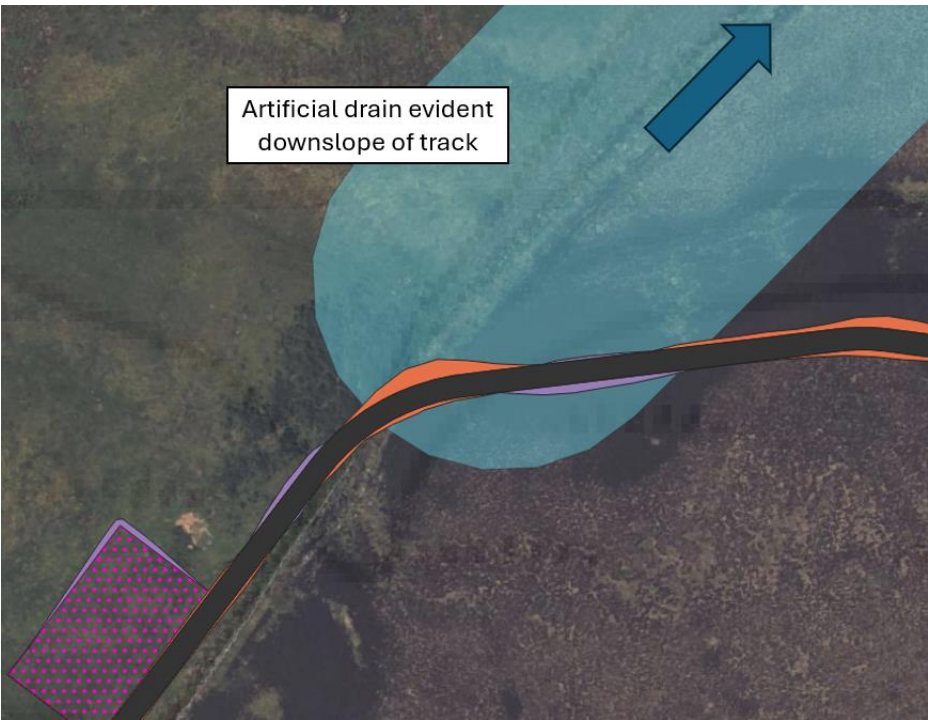
ID	Name	Width of watercourse (top of bank)	Watercourse Description	Infrastructure and Ancillary Works Description	Temporary or Permanent	Width of buffer strip achieved	Water feature upgradient or downgradient of Proposed Development	Potential Effect/ Comment	Additional Mitigation	Photograph
A	Unnamed drain	No channel at encroachment location. Strip of boggy vegetation measures ~3.5m. Becomes artificial drain further downslope.	No distinct channel – boggy area with vegetation.	New access track	Permanent	22 m	Downgradient	<p>Flow path analysis indicates that surface water runoff paths are from the proposed track towards the drain.</p> <p>At the closest point, the proposed track is ~4m higher than the drain. There is a risk of sediment/pollution entering the water environment during construction.</p> <p>Embedded mitigation (i.e. construction SuDS and permanent drainage) will be included in the design. Surface water runoff will be treated and attenuated.</p> <p>Buffer width is considered adequate for the size of water feature.</p>	Additional mitigation (e.g. silt fences, settlement ponds) will be installed during construction to reduce the risk of sediment/silt run-off during construction.

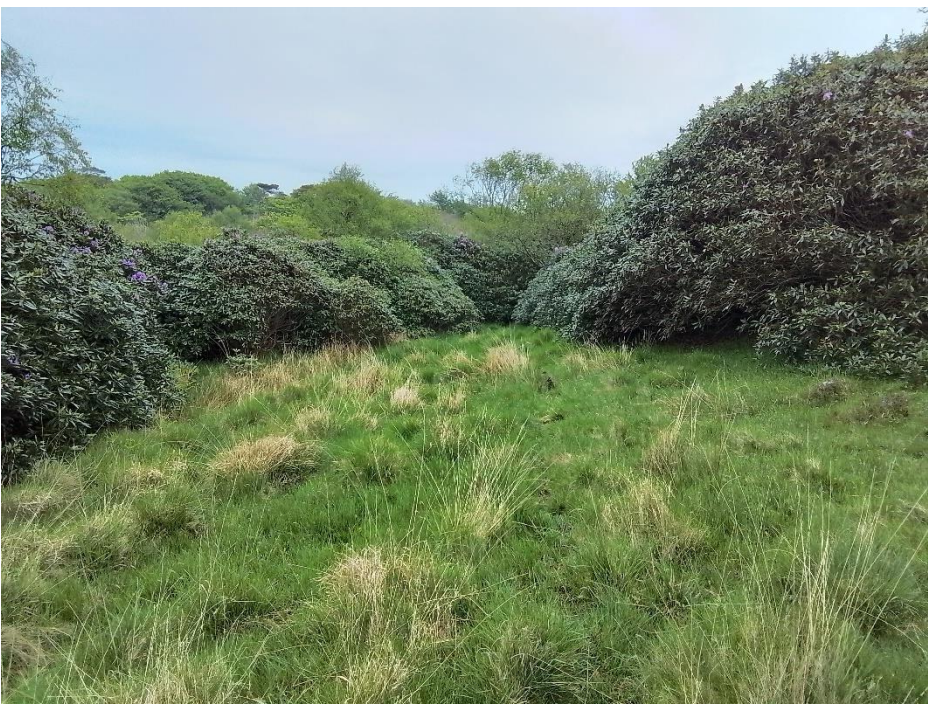
B	Unnamed drain (unconfirmed)	Unknown	<p>The drain is depicted on the 1:25,000 OS map however it could not be accessed due to <i>Rhododendron</i> scrub.</p> <p>There is no indication of a channel, flow pathway or water at the closest point downgradient of the drain.</p>	New access track	Permanent	~5 m from the drain endpoint depicted on the OS map. However, the drain is likely to begin further south due to the underlying topography (if present at all).	Upgradient	<p>The presence of the drain could not be confirmed. However, given that it is upgradient of the new track, there is low risk that sediment/pollution will enter into the drain.</p> <p>The mapped drain sits 4 m higher than the proposed access track</p>	<p>Further investigation to locate this drain will be carried out prior to construction.</p> <p>If it is present, additional mitigation will be installed during construction to reduce the risk of sediment/silt run-off during construction, if required. -</p>

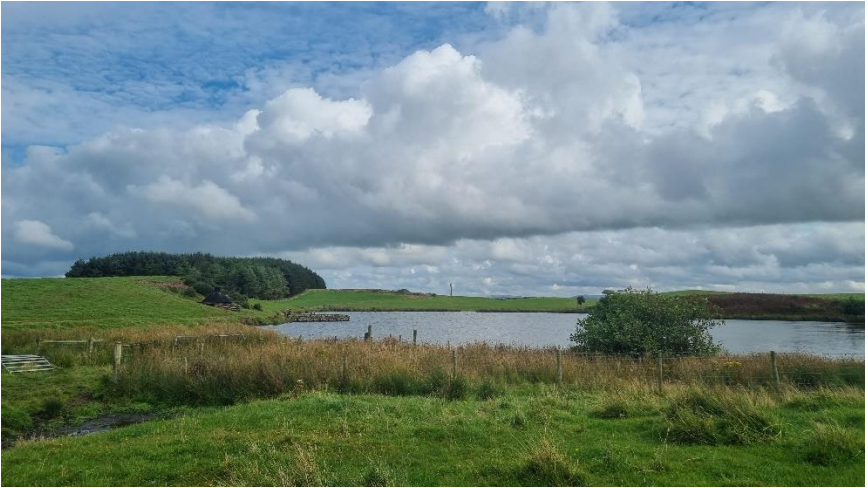
ID	Name	Width of watercourse (top of bank)	Watercourse Description	Infrastructure and Ancillary Works Description	Temporary or Permanent	Width of buffer strip achieved	Water feature upgradient or downgradient of Proposed Development	Potential Effect/ Comment	Additional Mitigation	Photograph
C	Loch More	N/A	A small loch in the centre of the Site	Upgrades to existing access track	Permanent	24 m	Upgradient	The loch sits ~2-3 m higher and upgradient of the track so there is unlikely to be a direct effect resulting from the construction and operation of the track.	No additional mitigation needed

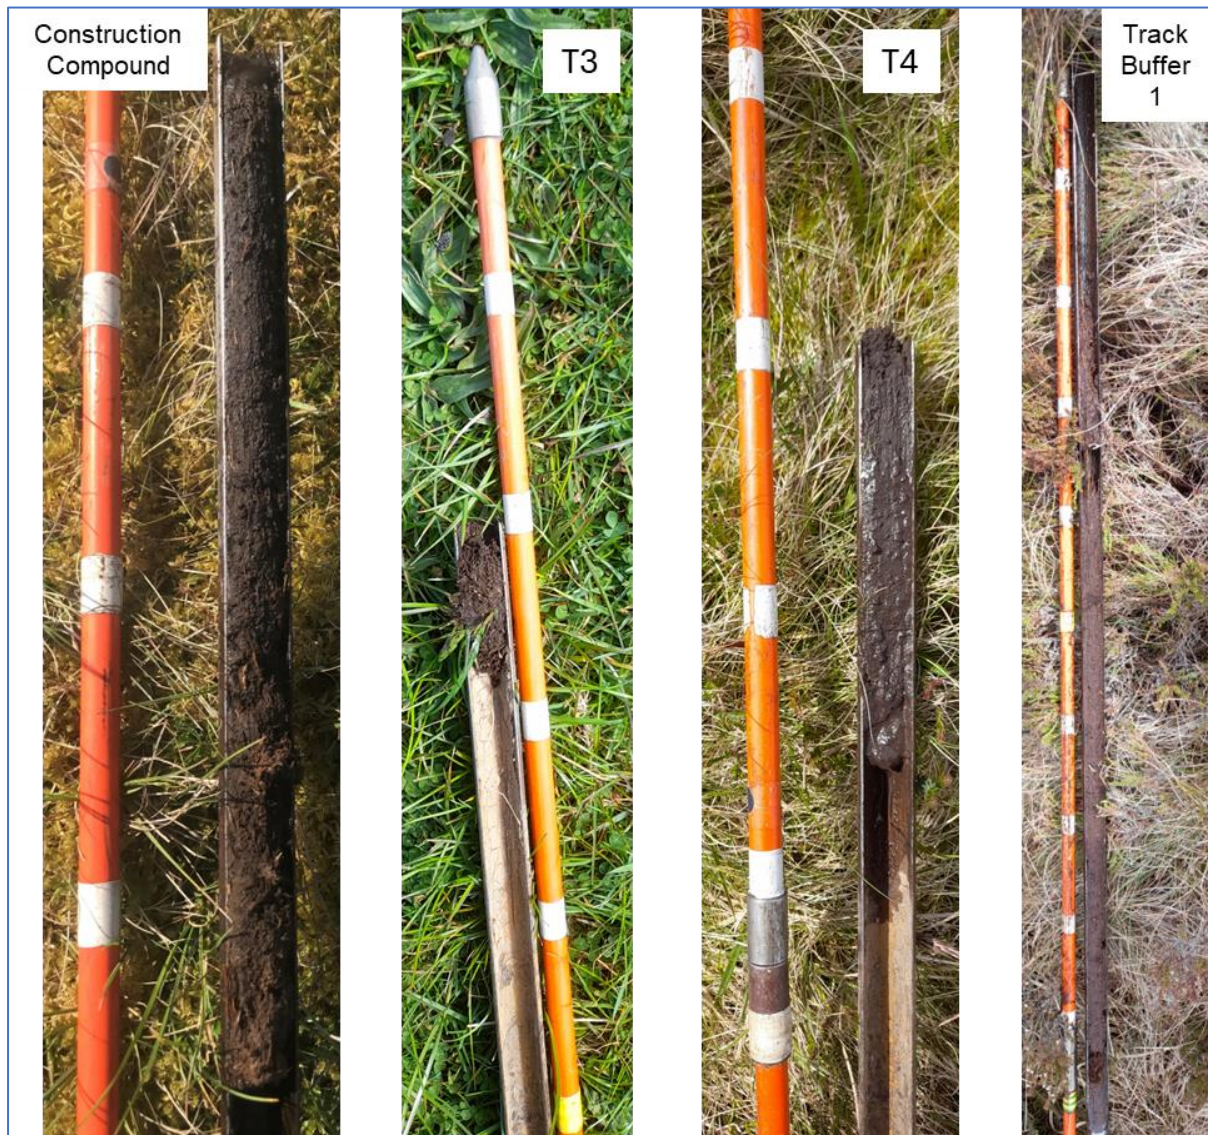
**Photo 1: Representative peat cores**

**Table 2** shows the information collected from the peat coring. A total of 9 cores were taken; the locations of which are shown in **Figure 4**.

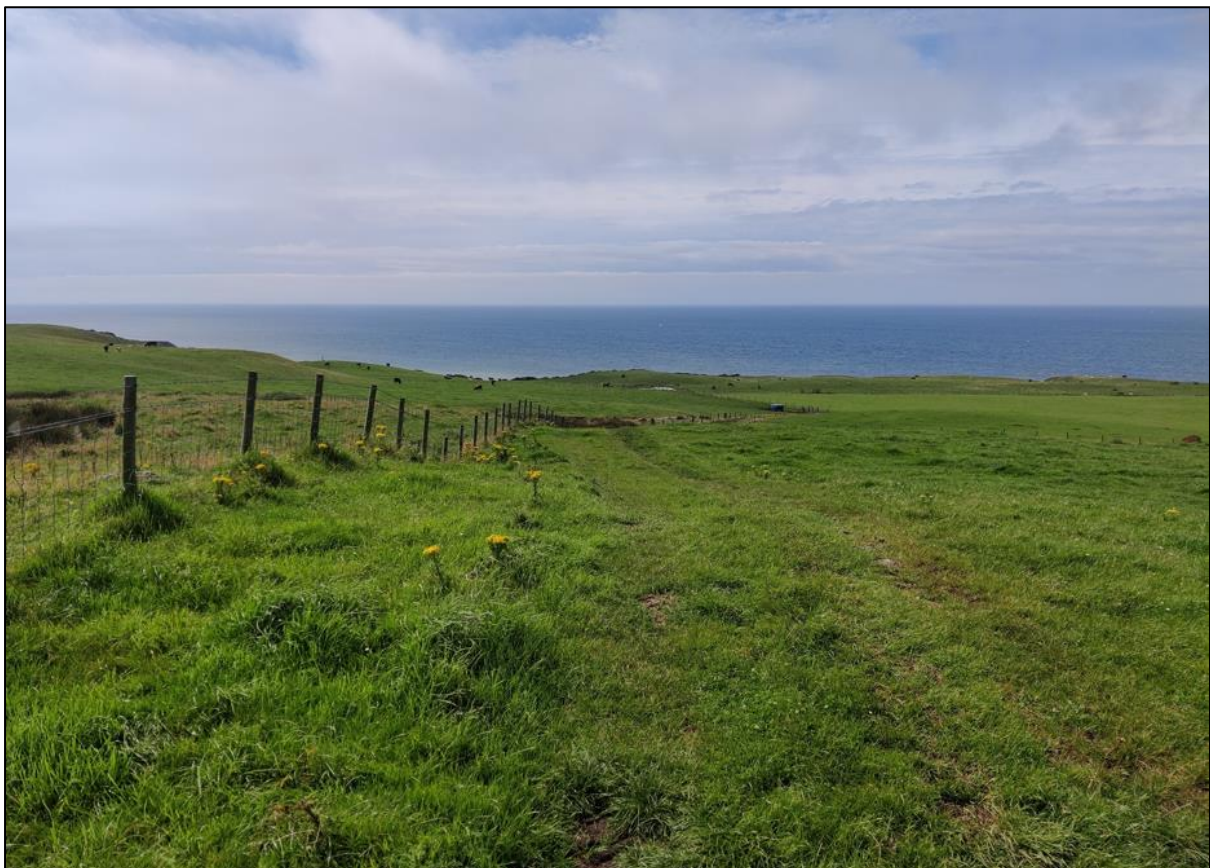
**Photo 2: The pastoral grassland in the western part of the survey area.**

The survey area within the Site is composed predominantly of undulating grass fields with limited areas of peat in areas of proposed infrastructure; see **Photo 2** for an example of the typical land cover. Most of the grassed area within the survey extent had been extensively grazed by sheep and cattle. **Photo 3** shows the soil horizon in the eastern part of the site, showing no peat. It should be noted that there were isolated small pockets of peaty soil in topographic depressions in the western part of the survey area (see **Photo 4**).

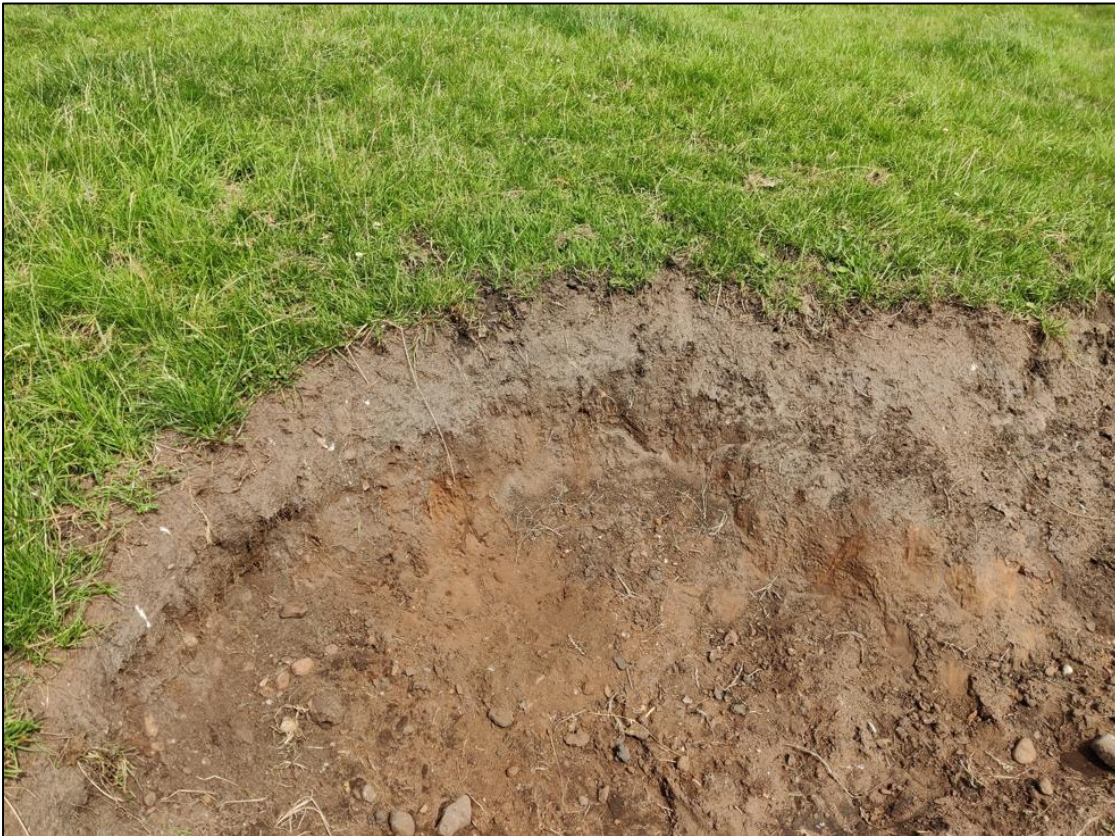
**Photo 3: An exposed soil horizon in the eastern part of the survey area.**

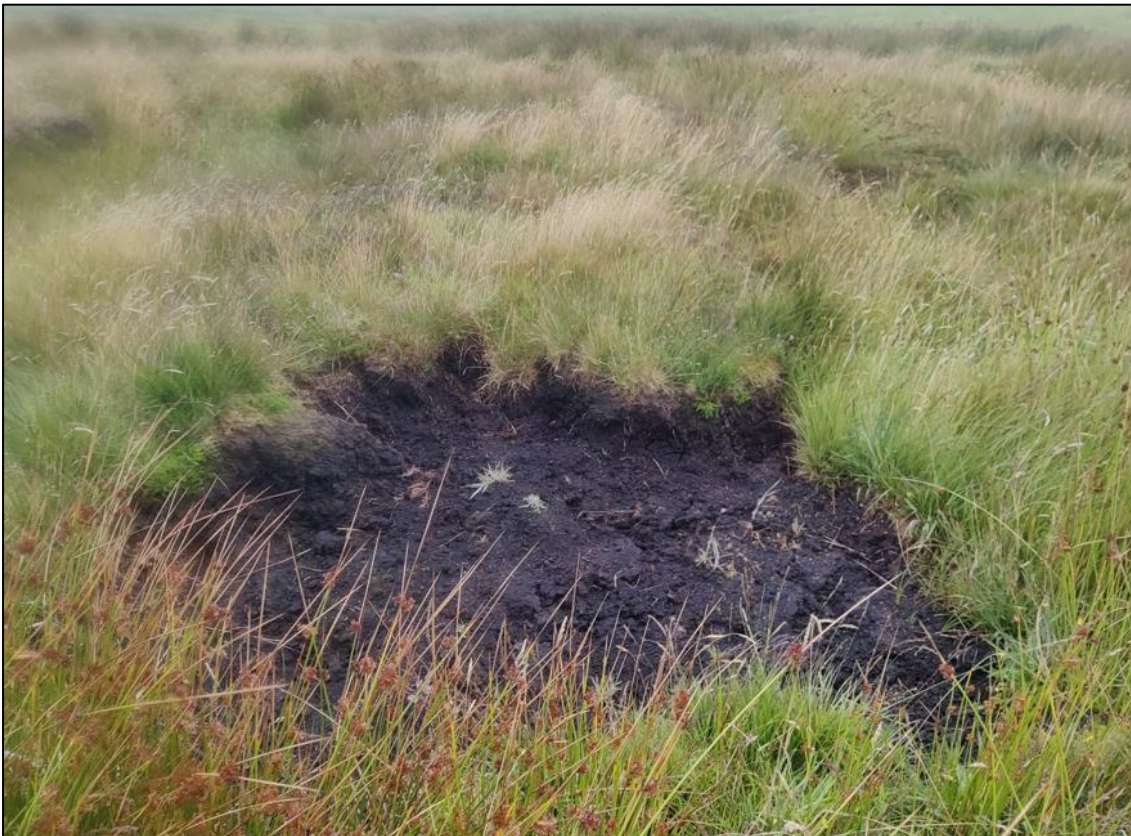
**Photo 4: An example of an isolated pocket of peaty soil in the western part of the survey area.**

Local topography on the site affects the peat distribution across the survey area with deep peat found in local topographic low points in the western part of the Site; an example of an area of peat at Galdenoch Moor is shown in **Photo 4**. The most extensive area of peat was found on Larbrax Moor, a slightly raised plateau of peatland located in the eastern part of the survey area.

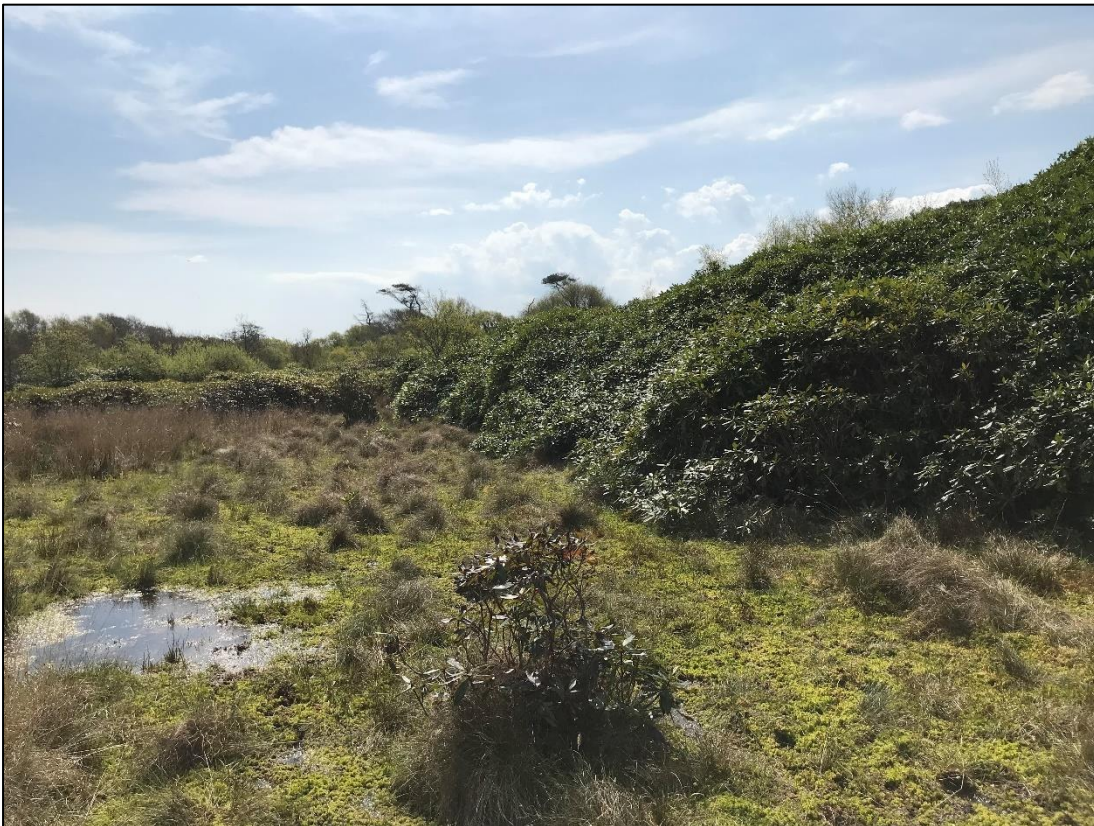
**Photo 6: The quaking bog in the east of the survey area.**

A small area of quaking bog was also found in a topographic depression close to the B738 in the east of the Site, indicating waterlogged conditions in the peat (**Photo 5**).

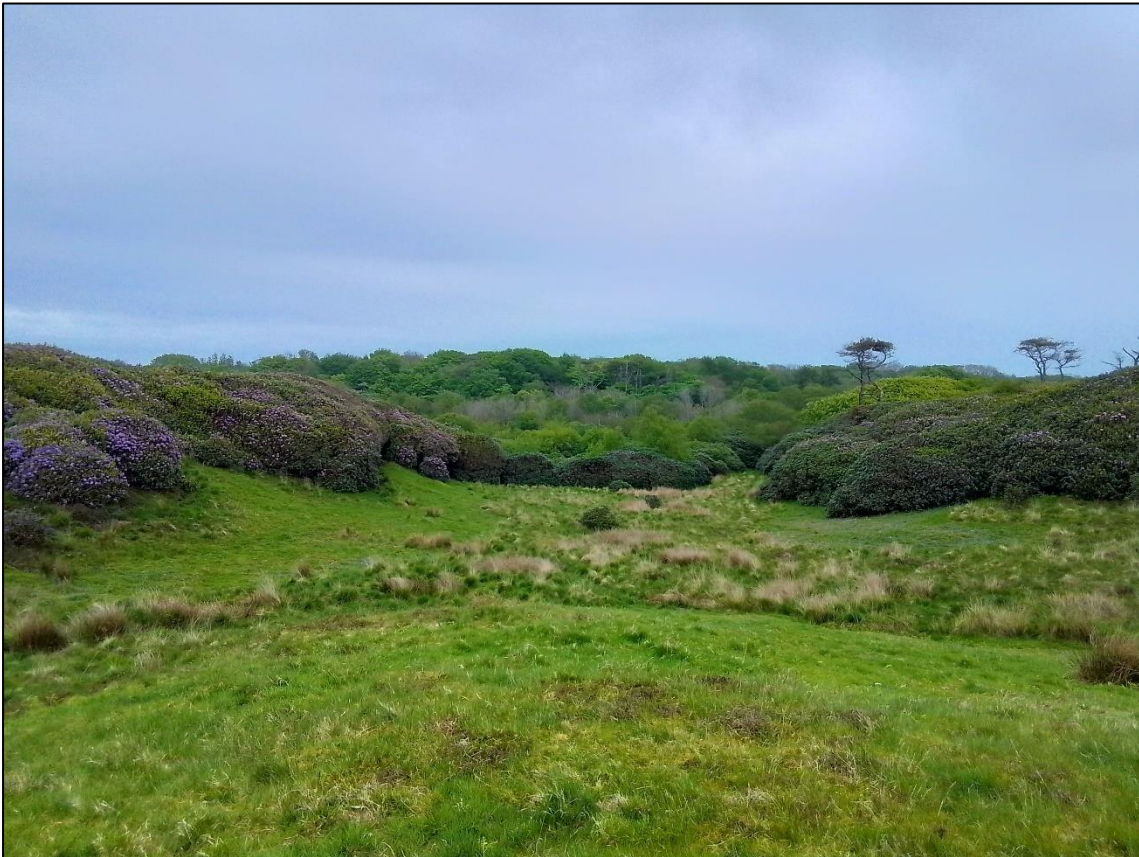
Photo 7: Rhododendron lining the eastern boundary of the site.

An approximately 60m wide strip of dense *Rhododendron ponticum* scrub lines the eastern border of the site, making it largely inaccessible for probing (**Photo 7**). A small area which the track crosses over is identified as Class 1 peat on the NatureScot (2016) Carbon and Peatland map but overlaps with the location of *Rhododendron* on the ground (**Figure 2**). Although there is some deep peat here, this type of vegetation is not peatland. Therefore, this area could not be considered Class 1 peat. Similarly, the field just north of the road leading to Meikle Larbrax Cottages is identified as Class 1 on the Carbon and Peatland map but is in fact pasture and contains no peat (**Figure 2**).

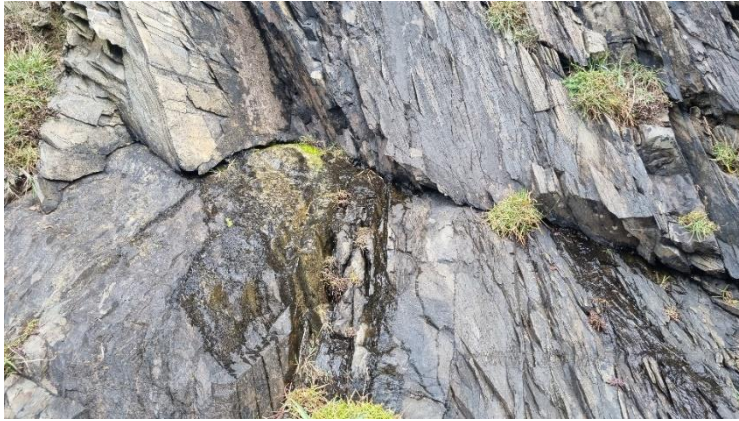
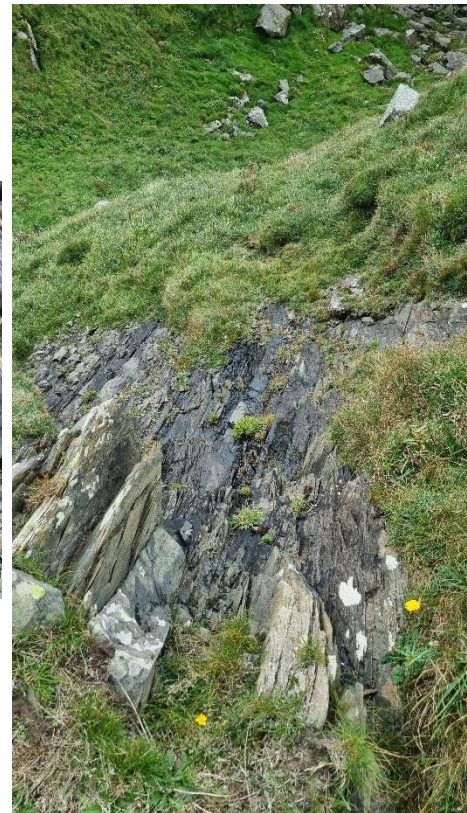
Photo 1: (a) Fracture-fed seep (b) Moderately Dependent GWDTE, looking down the cliff).

GWDTE 1 is located close to the top of the coastal cliff face along the western edge of the Site. A distinct fracture-fed seep was observed coming out of the cliff indicating a groundwater contribution (**Photo 1**).

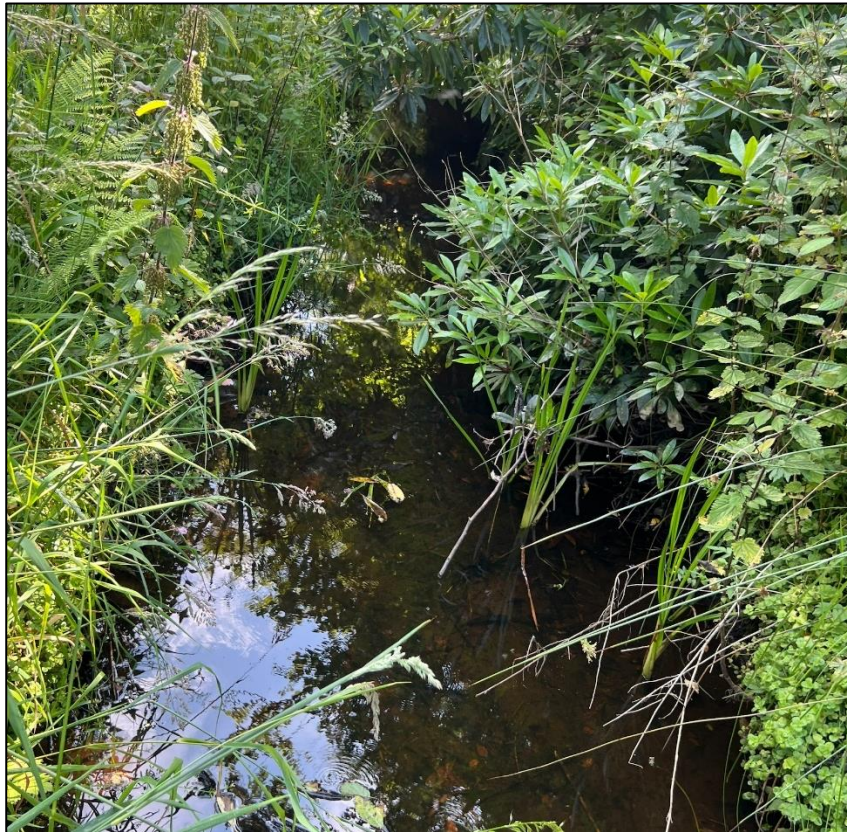
**Photo 1: Green Burn Downstream of B738 Crossing**

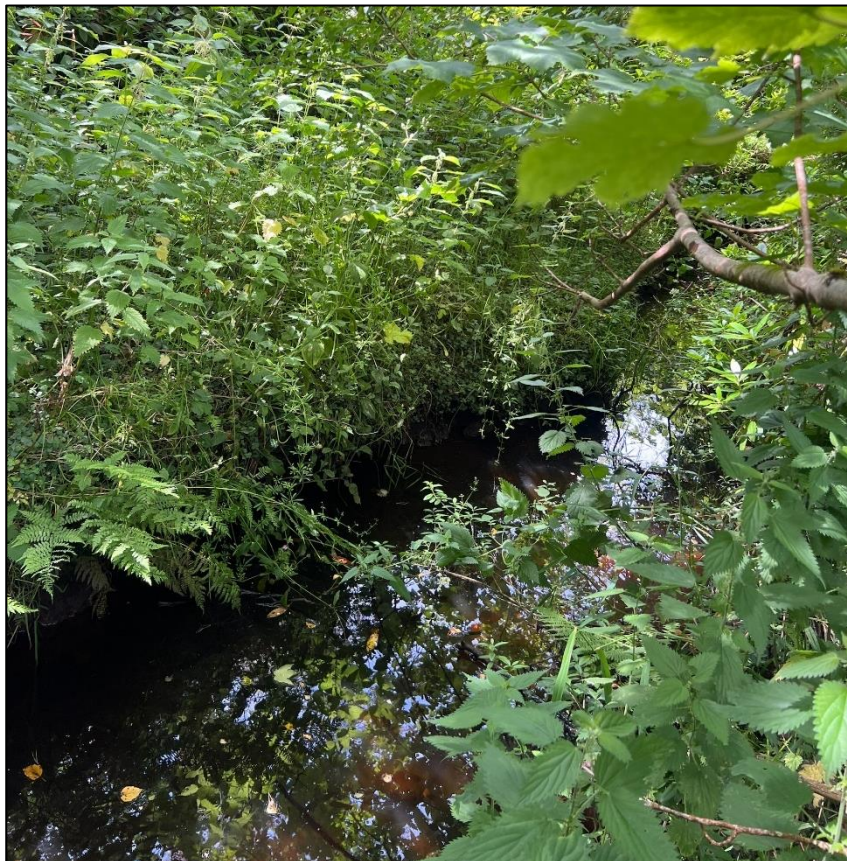
**Photo 2: Green Burn Immediately Upstream of Proposed Crossing**

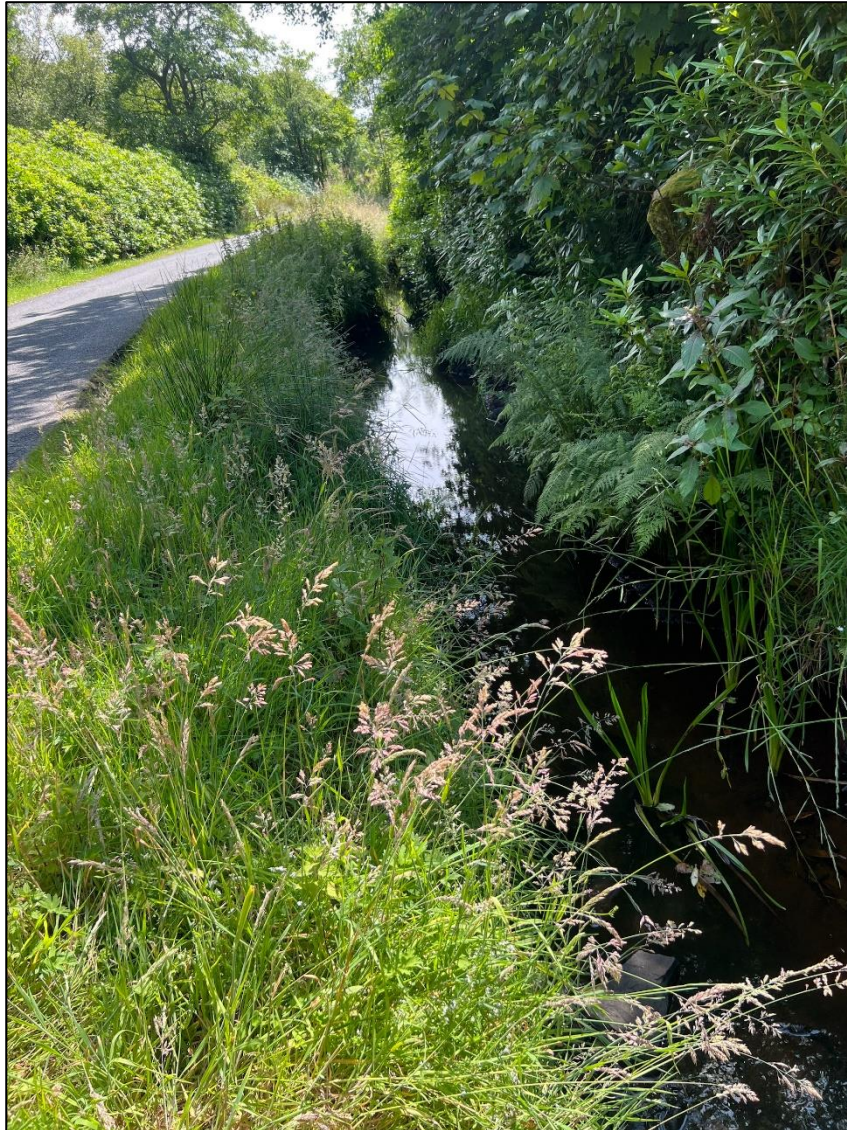
**Photo 3: Green Burn flowing along the eastern Site boundary (next to the B738), looking upstream**

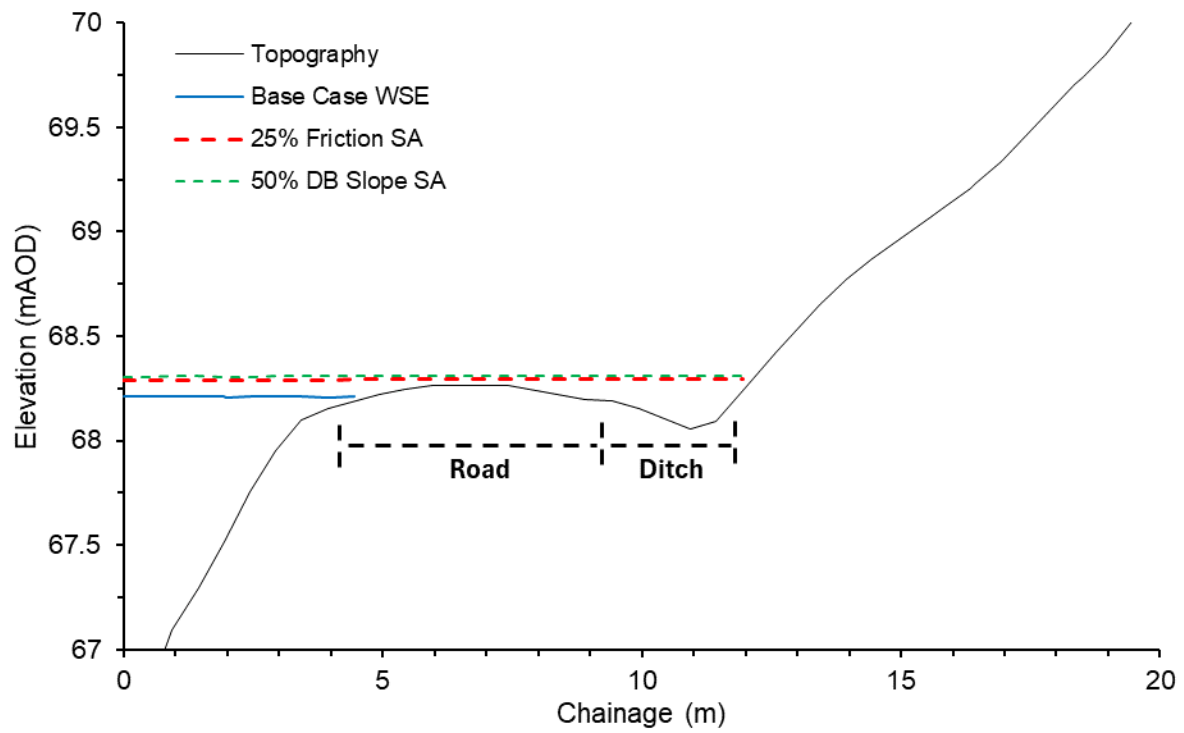
**Figure 6: Cross Section of Water Levels at Area of Greatest Increase**

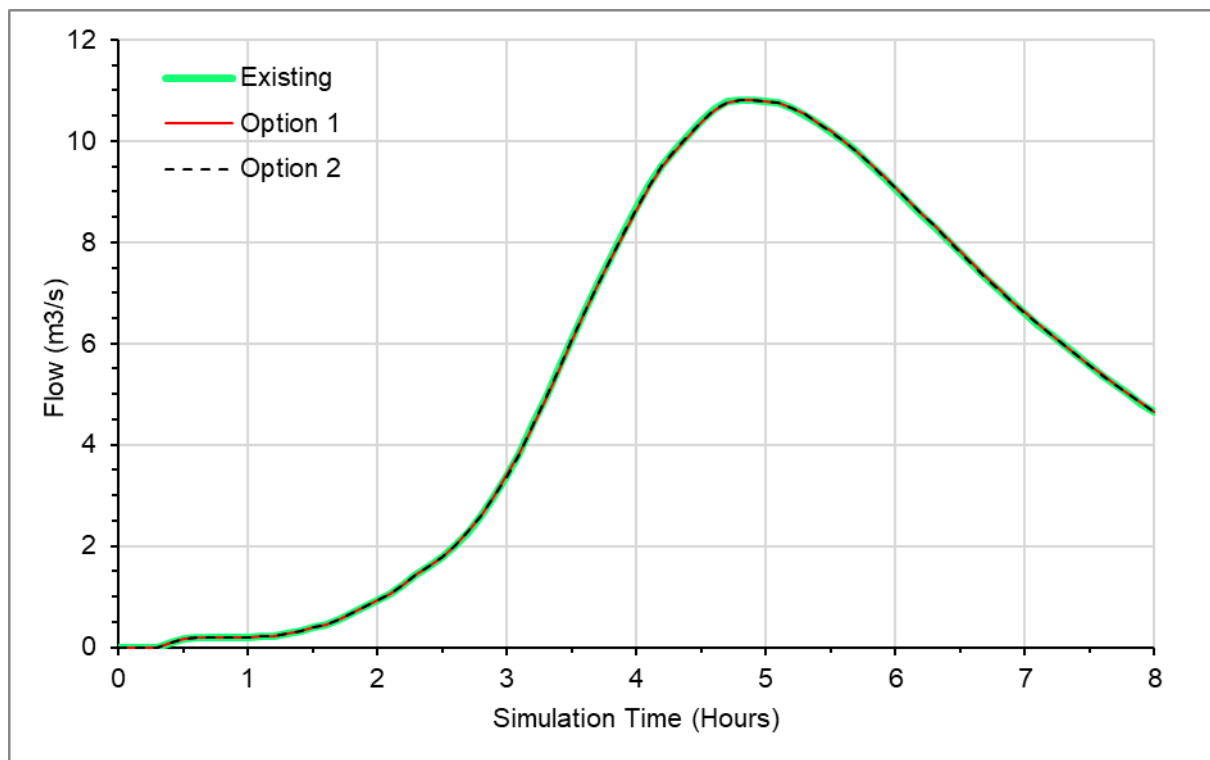
Figure 11: Comparison of Flows Downstream of Crossing

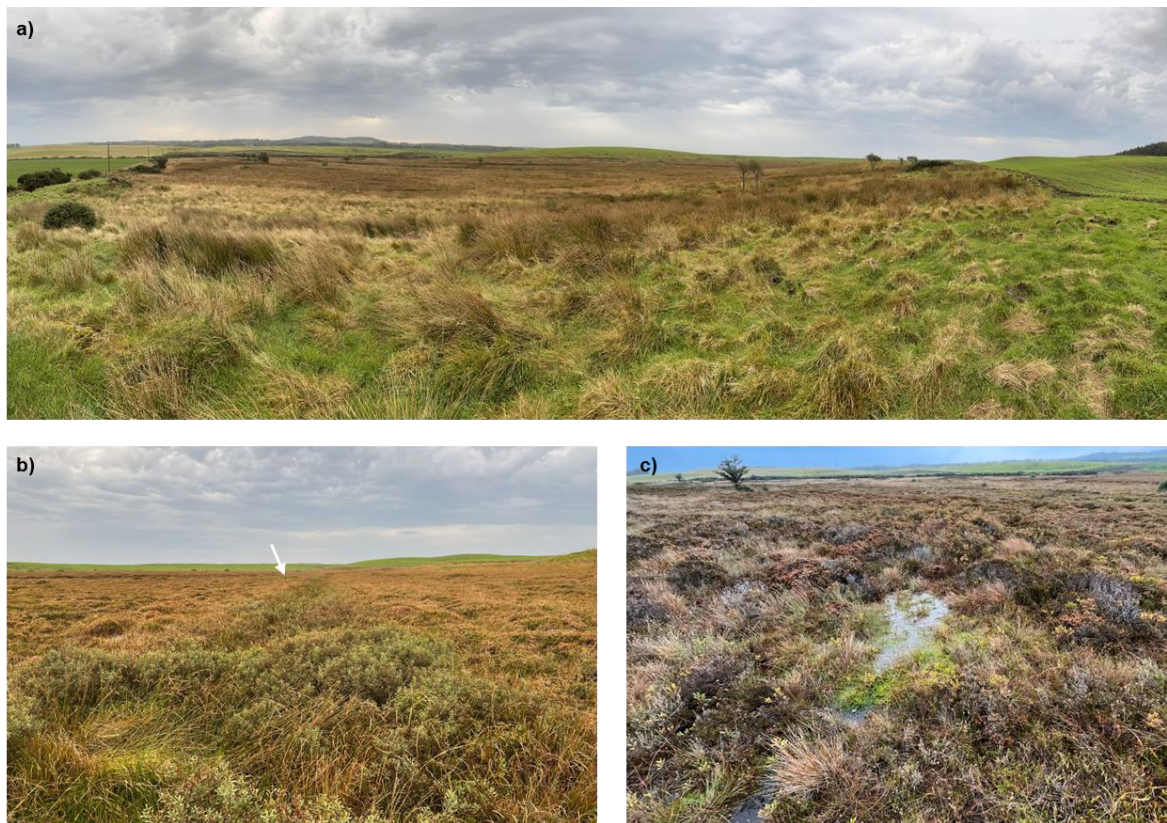
**Plate 3.2 a) Galdenoch Moor located in a subdued valley, b) a subtle drainage line marked by a slight vegetation change (arrowed), c) a rare bog pool within Galdenoch Moor**

Galdenoch Moor has been subject to artificial drainage in the past, with a series of linear moor drains running northeast across the very flat moor surface to join Galdenoch Burn (e.g. Plate 3.2). In contrast, Larbrax Moor shows little evidence of drainage on Ordnance Survey data, with some minor drains in the east. Galdenoch Burn is joined by Green Burn outside the site boundary to the south. None of the streams within the site have the capacity to transport landslide debris any significant distance due to their small dimensions and very low gradients. Both Galdenoch Burn and Green Burn are recorded by SEPA as being of Moderate status and Moderate ecological potential.

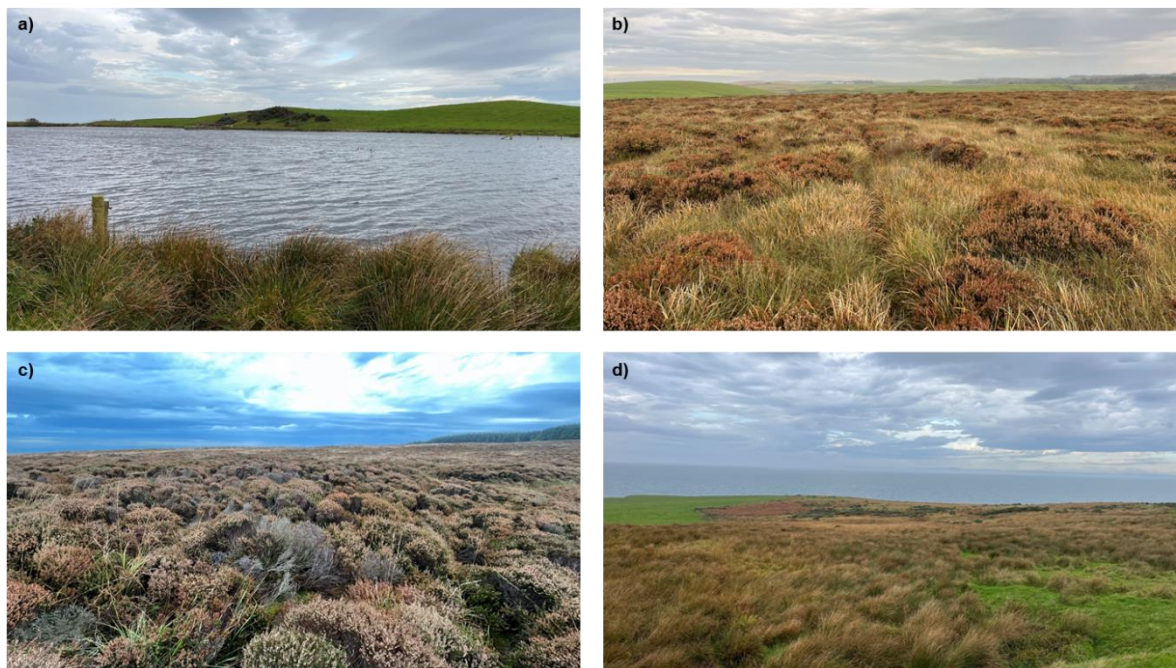
**Plate 3.3 a) Loch Morem in the centre of the Site, b) the flat, heather covered terrain of Larbrax Moor, c) heathland in the north of the site, d) scrubby grassland above cliffs in the west of the site**

The central 'plateau', on which Larbrax Moor is located and below which Galdenoch Moor sits as a valley mire (Plate 3.2), hosts several small lochans, the largest being Loch More (Plate 3.3), which has been partly realigned along its southeastern border (Figure 9.6.4).
